## Status of the Chloride Impact Study for the Southeastern Wisconsin Region

March 29, 2019

Quad States MPO Meeting

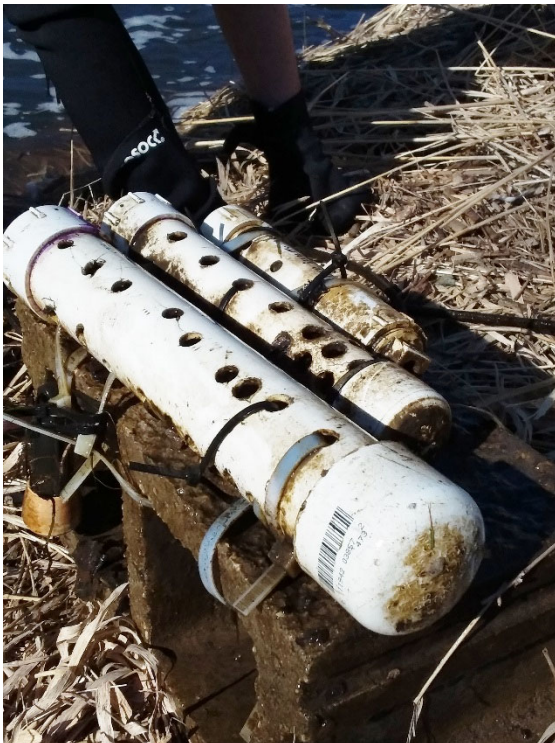
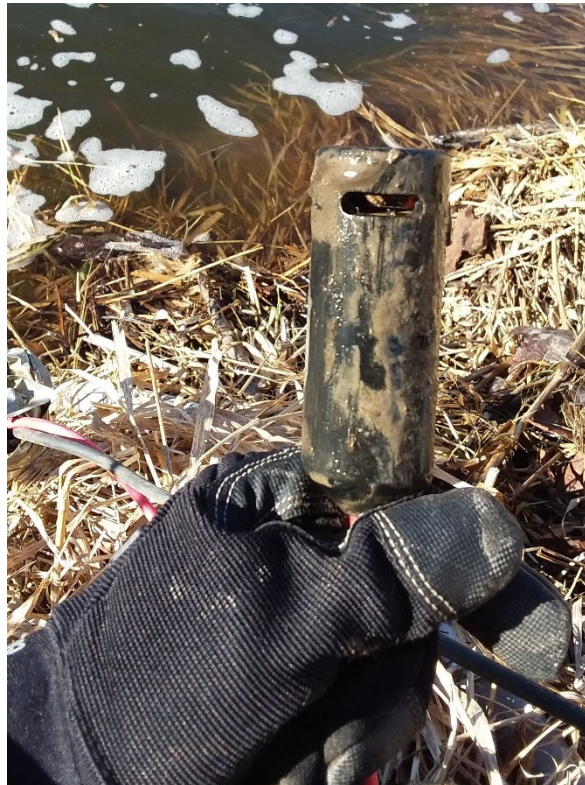
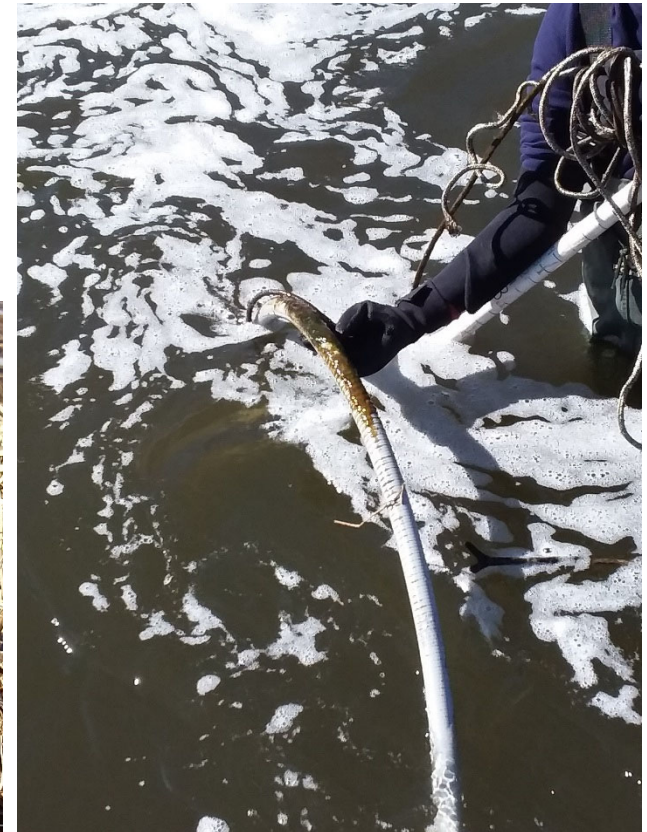
## Pilot Testing - Fouling

- March 14, 2018 field visit after 4 months of winter operation:
  - Sediment and biofilm accumulation

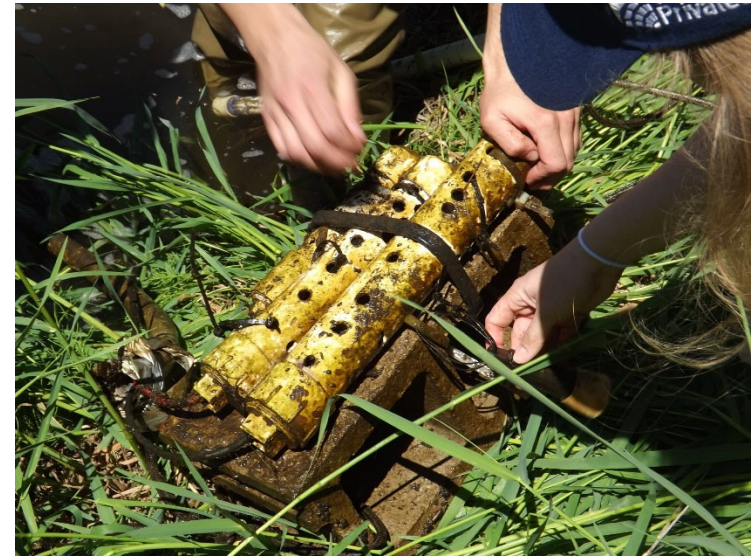
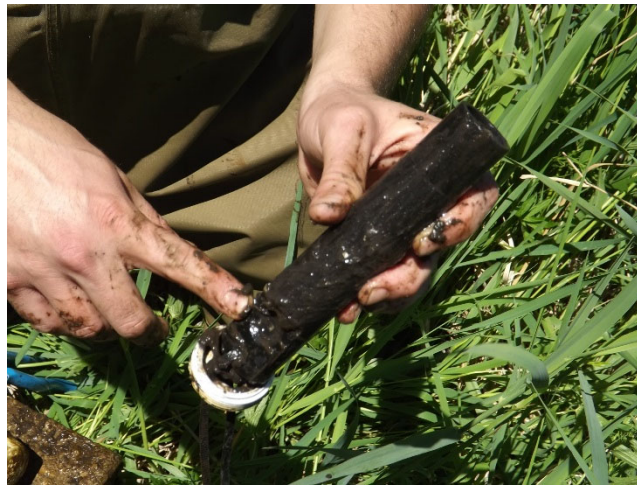
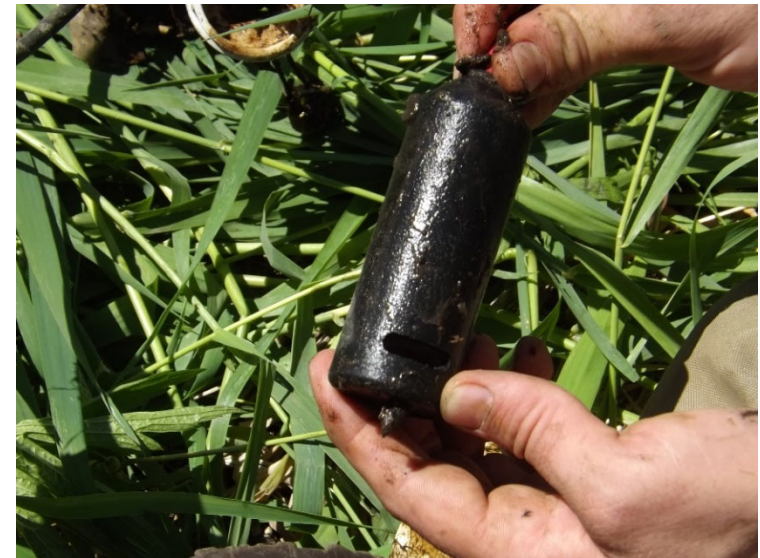
## Pilot Testing - Fouling

- June 1, 2018 field visit after 2.5 months of spring operation:
  - More biofilm accumulation on sensor housings with some caddisfly and stonefly larvae attaching to sensors
  - Sediment/debris still main fouling concern
  - METER Group device again seemed to have least amount of fouling impeding sensor function

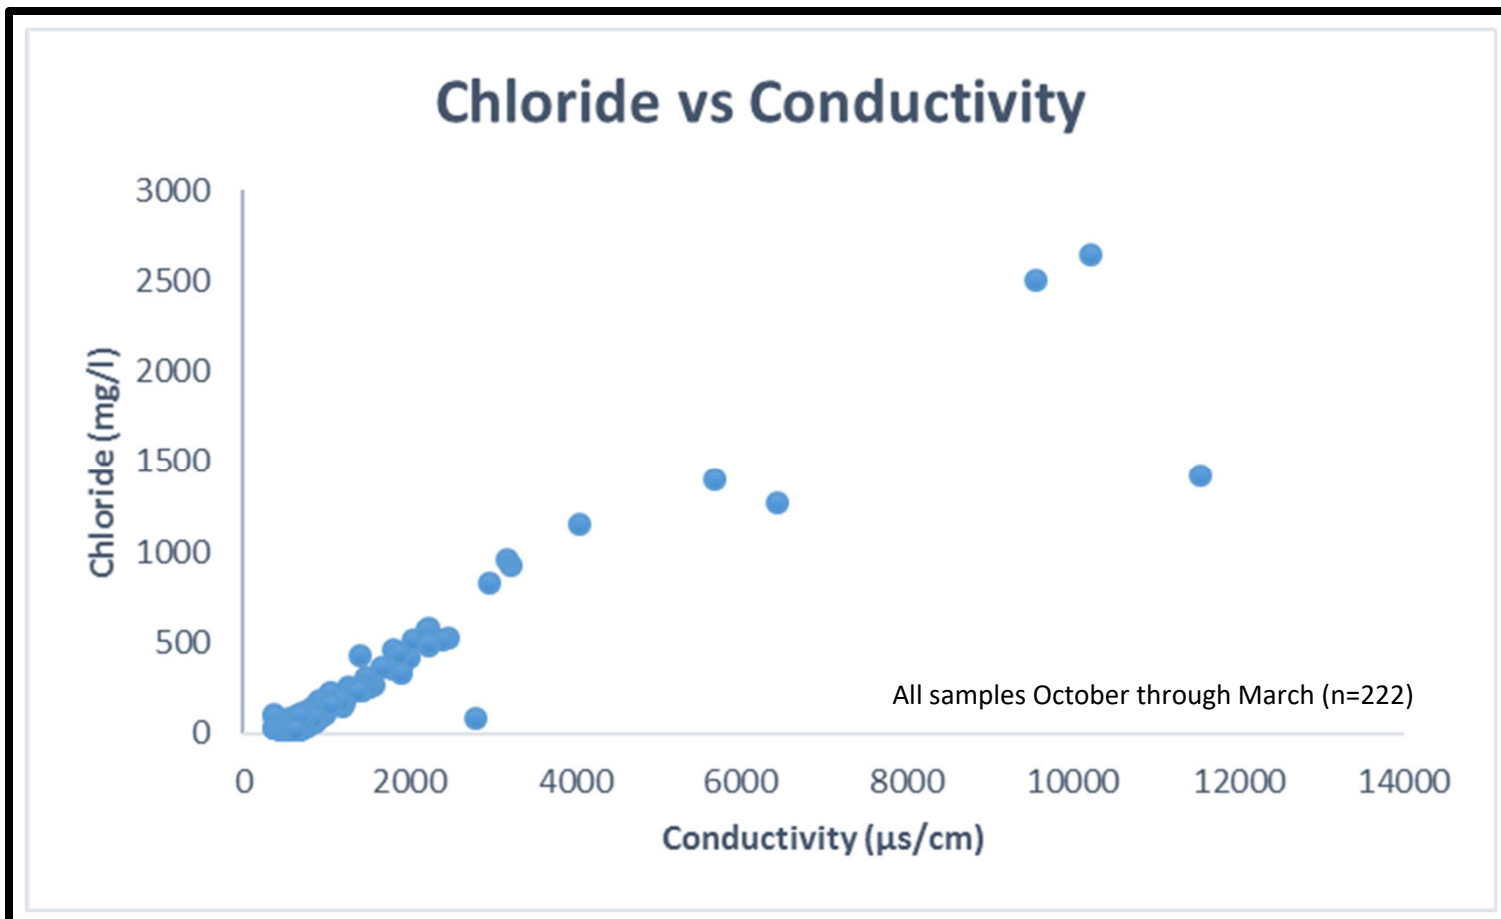
## Monitoring Locations – lab data to date

- 37 stream conductance sensors are collecting 5 minute data
- Monthly grab sampling began October 2018
- Event sampling was conducted winter 2019
- Three quarterly sample sets have been completed for 6 lakes in the Region (Geneva, Big Cedar, Little Muskego, Moose, Voltz, Silver (Washington Co))
